Intermittant Lock-up or Servo Error Problems

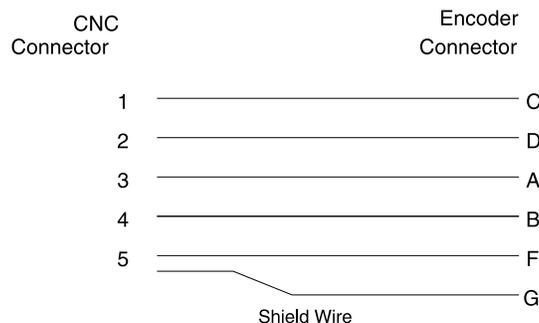
Encoder Cable Modification:

- 6. Verify that spindle encoder cable is new version** identified by white stripe near each end. If not, replace with new version or modify existing cable per drawing below.

To Modify Encoder Cable:
Splice wire to Shield Drain, both ends.
At encoder connector, solder wire to Pin G
At CNC, solder wire to wire at Pin 5.
